To fit a keel (the Spearfish story)

Spearfish is a 26 ft Cygnus Cyclone launched in 1992

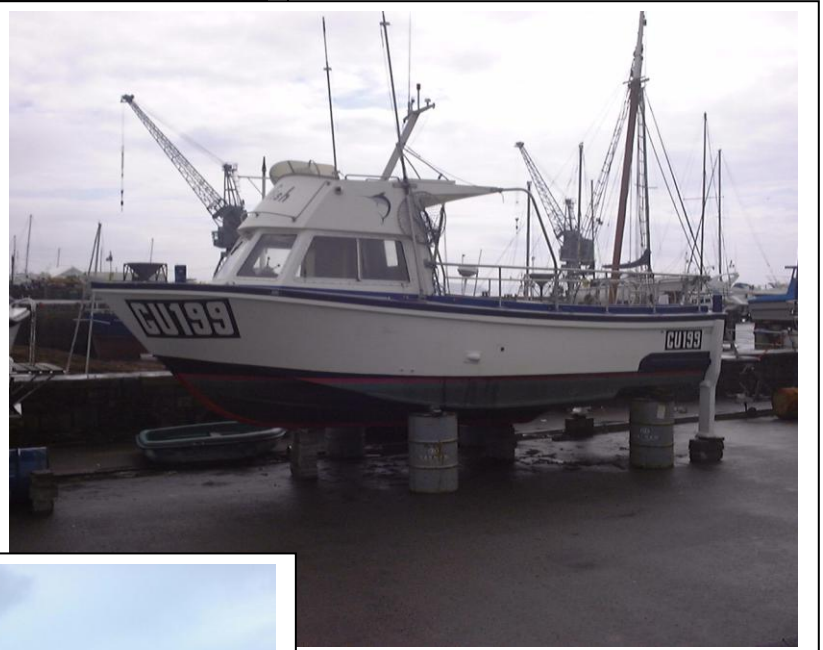
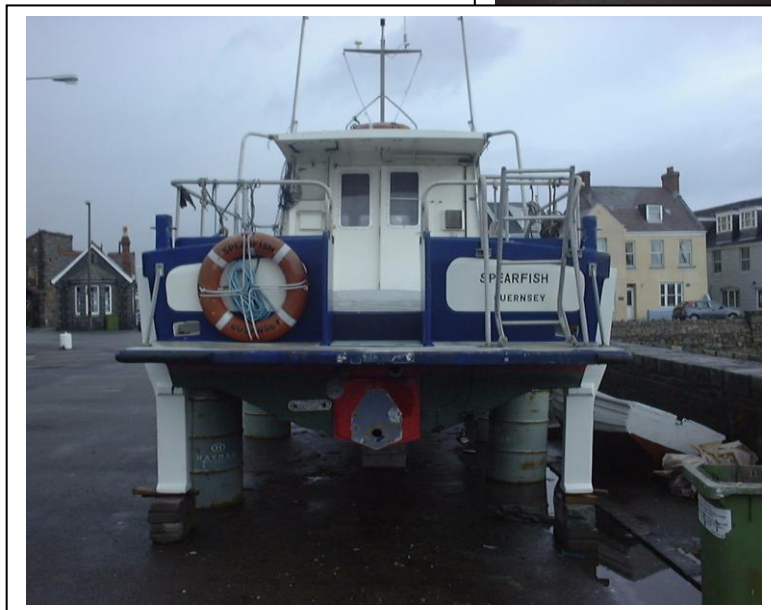
The engine, a 7.2 litre 260 HP V8 turbo diesel, had dropped a valve, sheared a piston and put a con rod through the block. Ouch!

Originally built to take a Stern drive, she was retrofitted with a surface drive. Note the small hole where the shaft from the surface drive emerged.

Need for a rethink. Decision time Junk all the drive chain, lengthen the hull under the swim platform, cut out the bottom and fit a full-length keel, complete with prop tunnel. Stick in a new big turbo diesel, somewhere amidships and with a down angle gearbox, a shaft, a prop and a rudder, convert power into motion. Easily said.

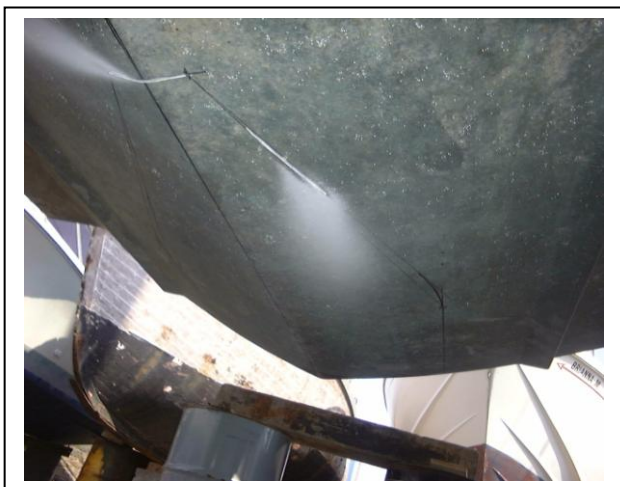
Remove all stern gear, exhaust, anodes etc
and mark out the cutting lines with a
permanent felt pen.

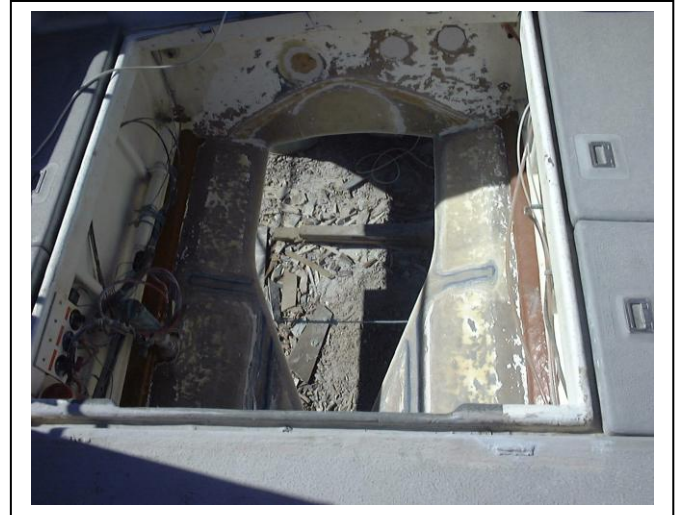
View from inside. Oh my God, there's a big hole in my boat! Next, only a few bits of engine bed to cut out. If only I knew.

Two weeks and about a zillion hours later the beds are gone at last. These were made up of two lots of beds, (from the stern drive engine position and then from the surface drive position). They comprising glassed over hard wood, ply and steel bonded one on top of the other and had to be reduced to matchbox size pieces using a grinder, saw, hammer and chisel. Phew! Next had to feather all of the edges of the hole ready to blend in the new piece. This is best left to last. Grind, feather, knock, chip, damn, curse, grind, feather, knock, chip, damn, damn, damn, etc.

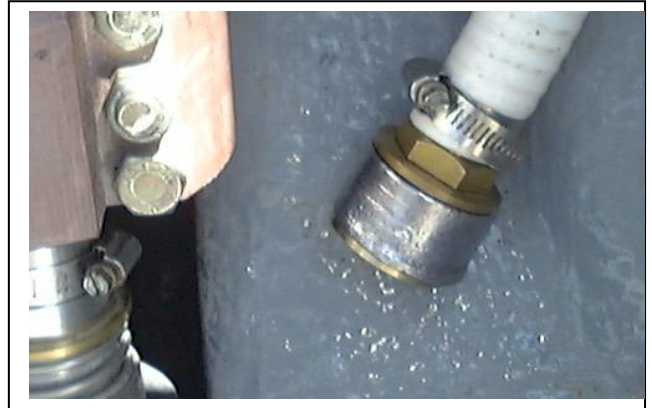
Connected up a fresh water hose and ran the engine. Found a small water leak but otherwise perfect. Fixed the leak and did a second test. Estimate 3 weeks to launch.
