To fit a keel (the Spearfish story)

Spearfish is a 26 ft Cygnus Cyclone launched in 1992

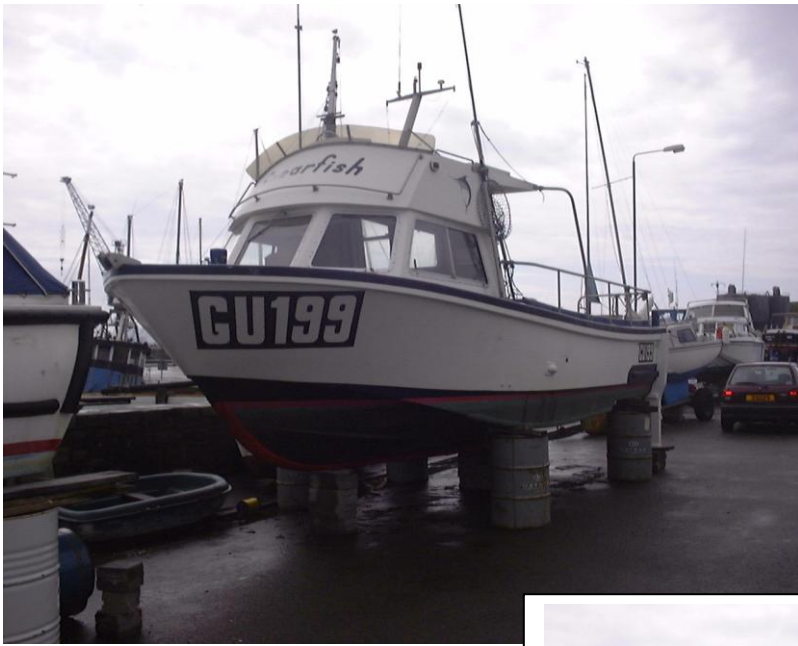
The engine, a 7.2 litre 260 HP V8 turbo diesel, had dropped a valve, sheared a piston and put a con rod through the block. Ouch!

Need for a rethink. Decision time Junk all the drive chain, lengthen the hull under the swim platform, cut out the bottom and fit a full-length keel, complete with prop tunnel. Stick in a new big turbo diesel, somewhere amidships and with a down angle gearbox, a shaft, a prop and a rudder, convert power into motion. Easily said.

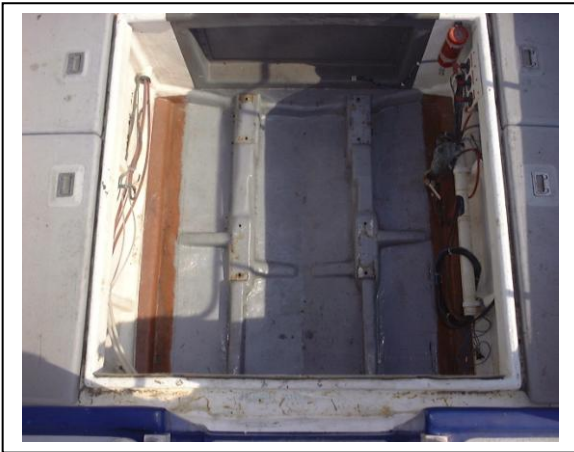
Inside the old stern engine compartment,
now sadly empty. Note the soon to prove
problematic engine beds.

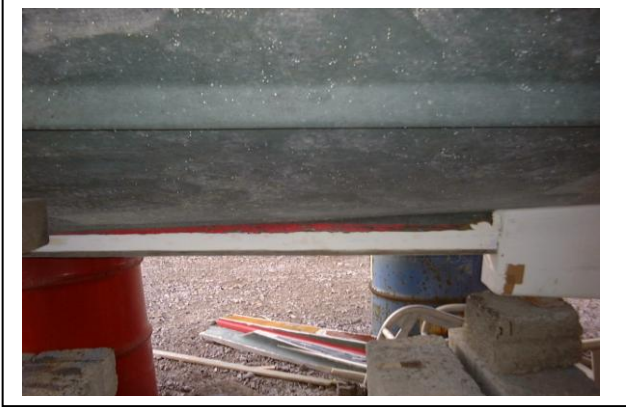
The new keel (white on the right), stopped short of the bow (left), leaving a step. This was done so as to avoid cutting out a slot in the hull beyond the forward watertight bulkhead.

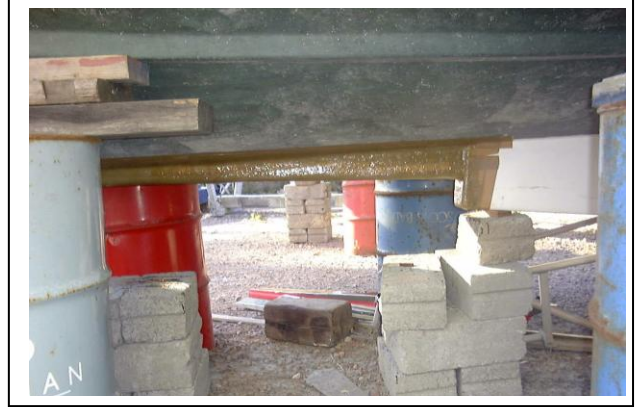
A false keel is to be moulded to fill in the step forward of where the new keel stops. Parcel tape covers the remaining stub keel prior to moulding. This enables the false keel to be removed for final glassing and eventually gelling in place.

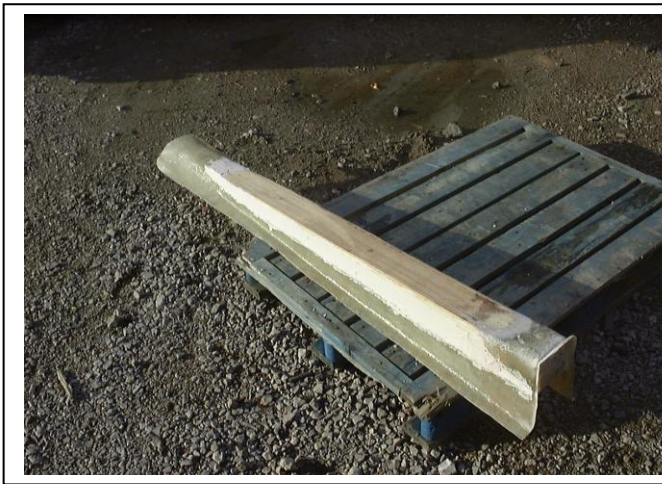
The false keel insert, now complete with laminated plywood filler piece has been removed from the hull for a clean up and application of the final GRP layers.

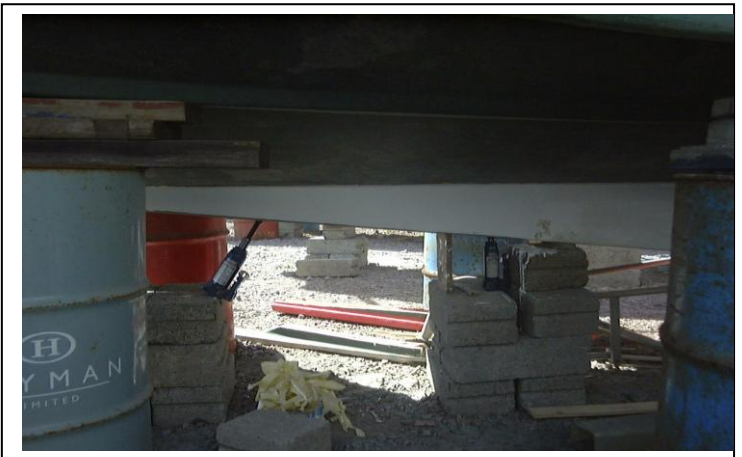
The false keel is now shaped, sanded and gelled. It was fitted in position and secured by bonding with wet gel – a very messy job. Fits well and looks good though.

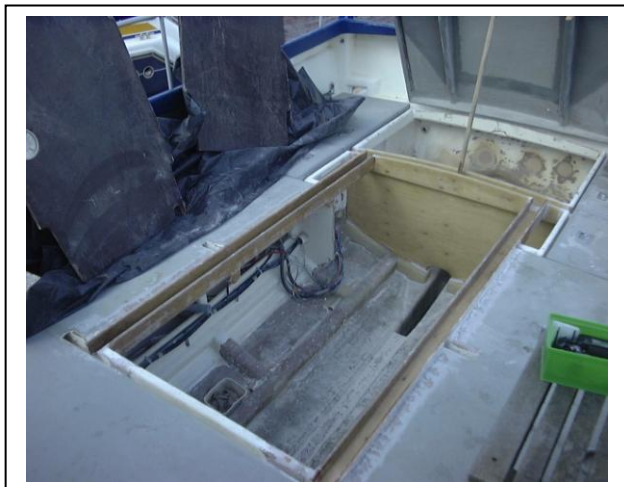
Meanwhile back on deck the side gutters for the new deck hatch are being fabricated. The new engine bulkhead is already in place. Note, in the bilges, the glassing over (boxing in) of part of the new keel, leaving just a sump.

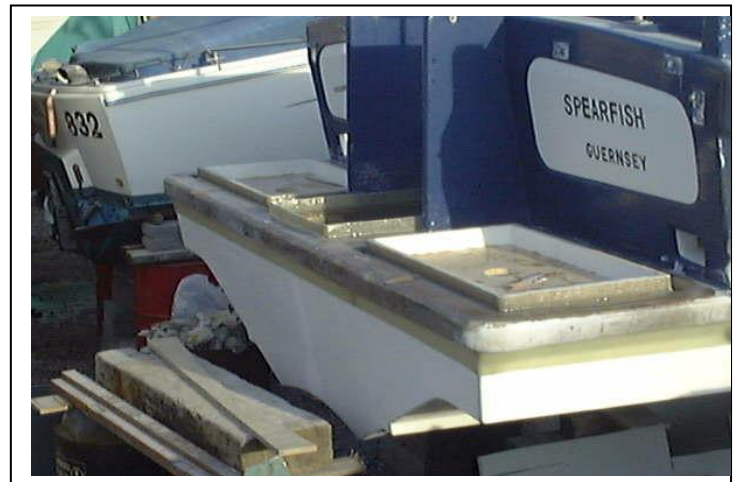
Out back the swim platform was due to have the cut outs glassed back in place. However, change of plan. Three wood/conti-board/parcel tape moulds have been used to facilitate glassing of a lip around the 3 openings prior to fitting some new bolt down hatch covers.

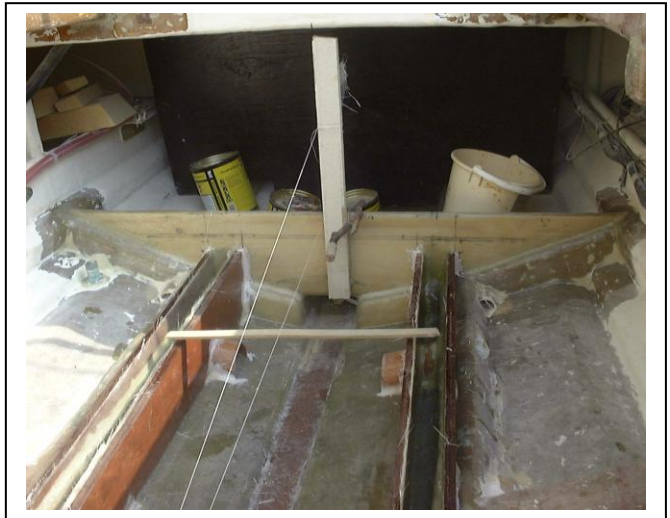
String lines everywhere. Lines for the prop shaft and engine beds were checked and rechecked. The new engine beds are box section, made from 20mm heavy-duty hardwood ply.

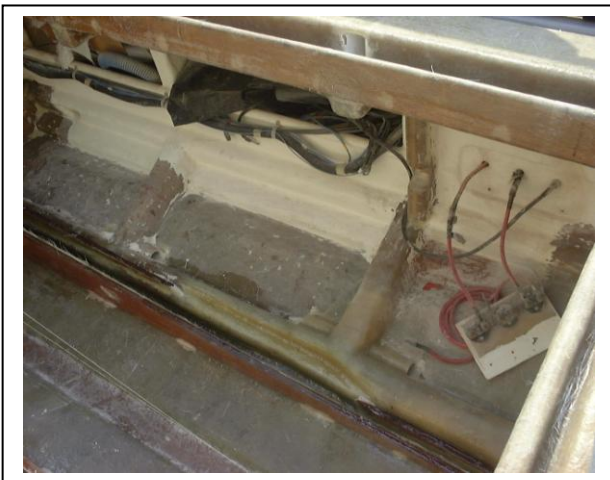
The beds were built on top of an existing stringer, but the back end needed a slice taken out to suit the engine angle. Note also the remains of the old engine bulkhead (forward of the battery switch panel), which has been ground, filled and glassed.

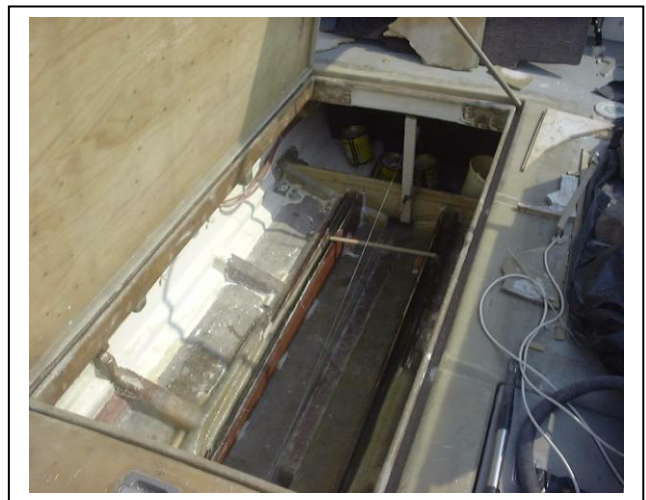
An over view of the whole engine bed area, now with the inside of the box ply beds glassed over. These will have a ply top (to complete the box shape) but with steel plates added as well.

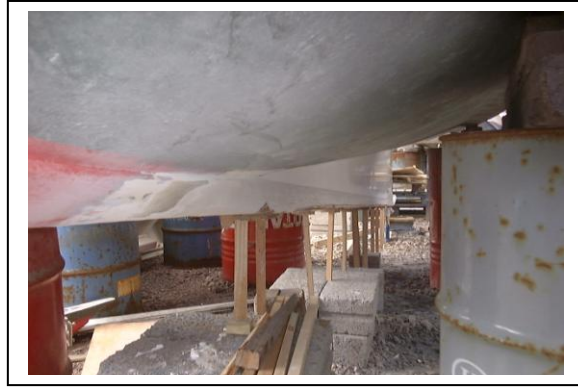
After gelling and sanding the outside of the keel shoe it has been stuck on with mucho wet gel. Lots of little bent sticks apply steady pressure after an initial shove with two hydraulic jacks.

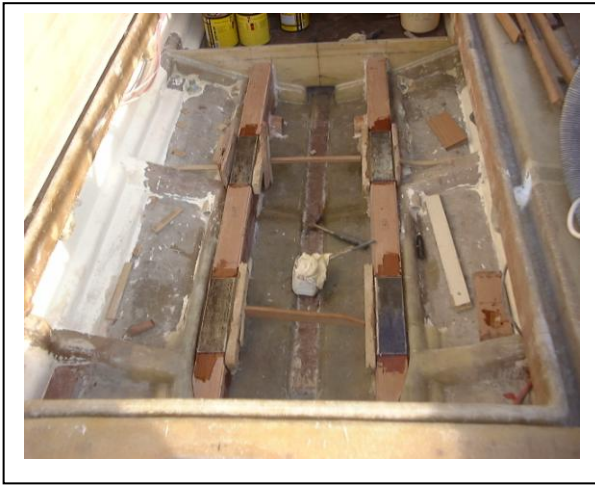
The ply tops of the beds are bedded down on gel with the 20mm steel plates bedded on wet mat.

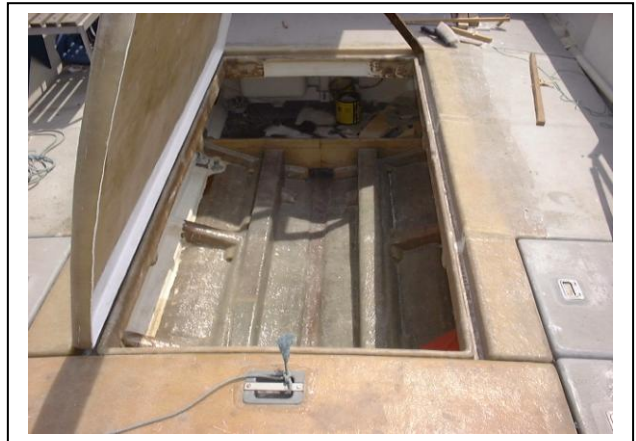
3x3 layers of 2oz give a 9mm covering to the beds. Matting edges were staggered eventually covering the whole engine bay.

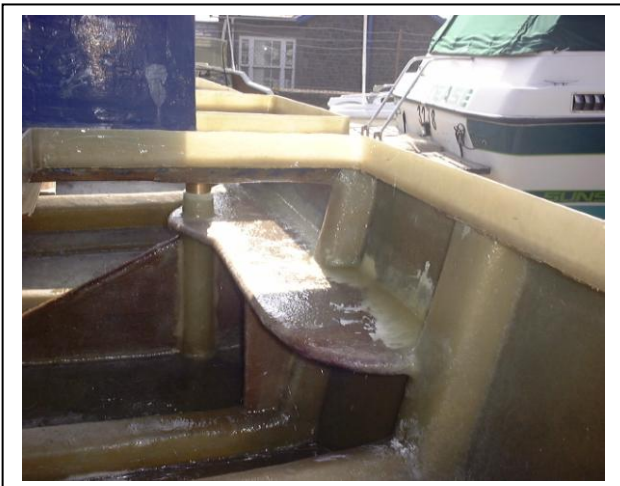
Inside the new rear compartment the GRP rudder tube has been fitted, strengthened by plywood knees and a plywood shelf. Shelf provides a base for the new hydraulic steering cylinder

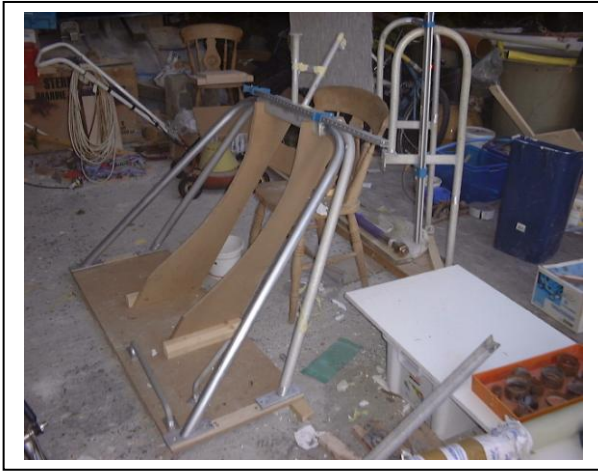
A new aluminium mast (tube hoop) was built around a temporary MDF jig, ready for welding. In the background is the ladder frame that required some serious repair following "modification" by another boat while I was moored up last year.

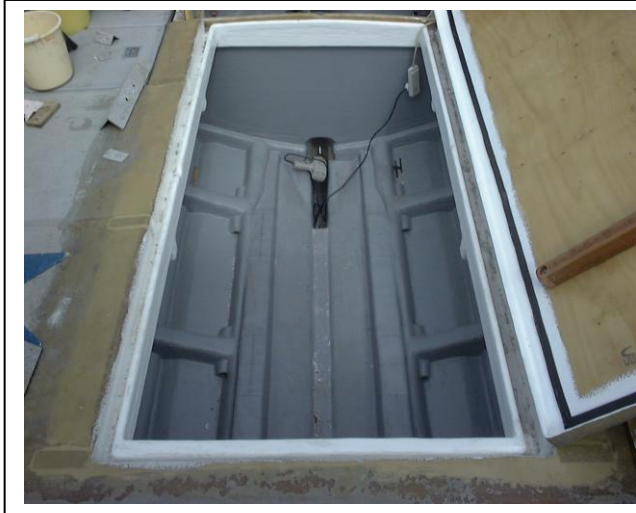
The finished gelled out engine compartment. The drill is being used to power a boring bar that was used to cut a path for the glass stern tube.

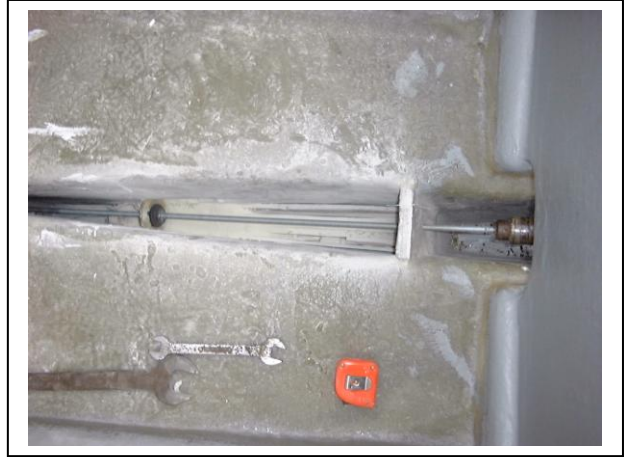
The boring bar is seen here inside the keel in the rear hold. A cut down grinding disc was attached to a piece of studding driven by a drill. Clever stuff but still very slow, like it took all day.

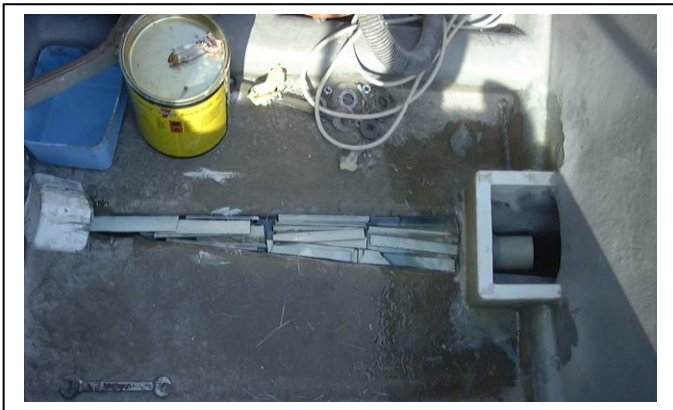
Once the hole was bored the glass tube was slid in place and the keel backfilled with off cuts and slow cure resin. An inspection hatch allows access to the front end of the stern tube so as to service the seal.

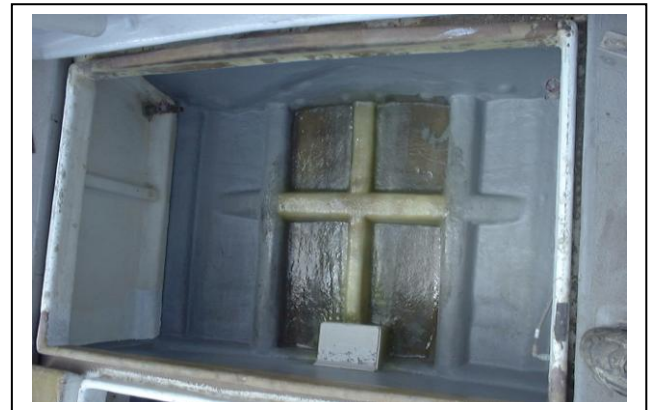
The keel is filled and overlaid with a few layers of mat. Ribs and stringers tie in to the existing structure. The inspection hatch now has a lid.

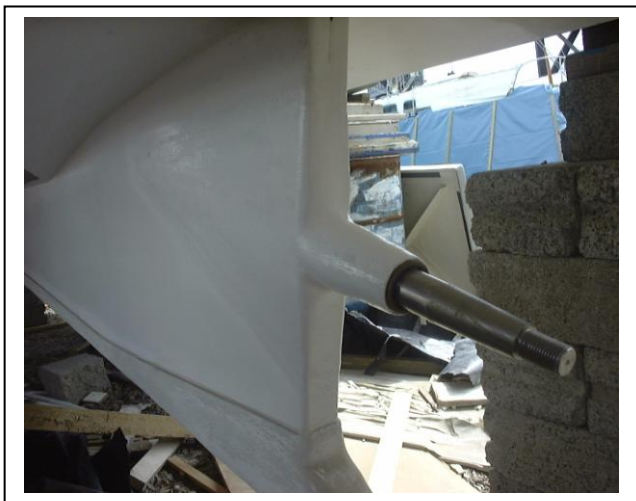
Where the hole bored for the stern tube broke out through the side of the keel a tapered overlay of eight layers of 2 oz mat was used to strengthen it. Multiple layer of gel repeatedly sanded has left an almost invisible streamlined bulge.

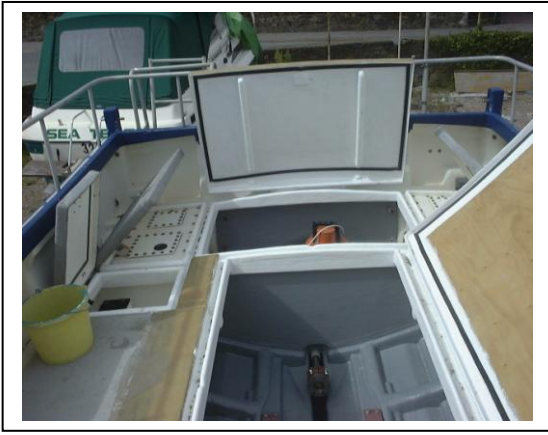
The undersides of all of the hatches were cleaned and new neoprene seals fitted. The new gear hold hatch has been gelled but the engine hatch still needs some further reinforcing and so is only gelled around the edge.

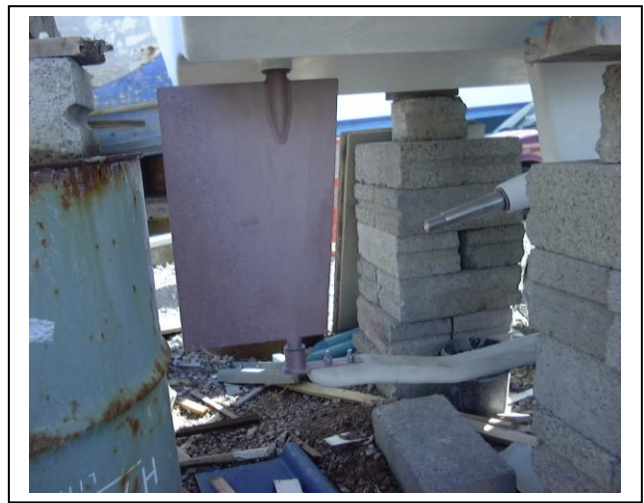
The rudder is now fitted in place; note the neat bottom bearing (made by me). The whole lot is made of 316 (A4) stainless but it has all been epoxy coated to form a base for the antifoul.

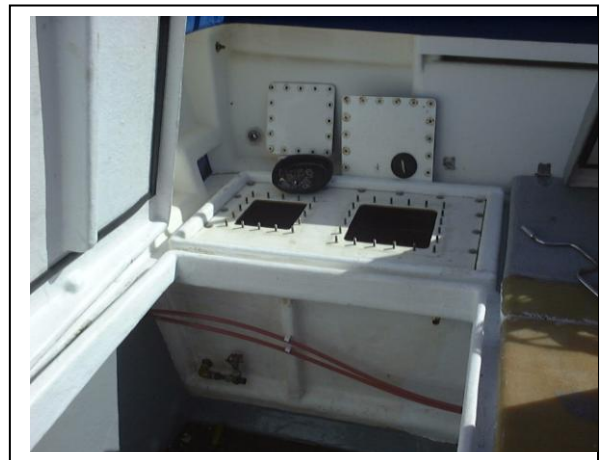
The inspection hatches for the built-in fuel tanks were removed and the tanks cleaned. A new outlet and master shut off valve was installed in each tank.

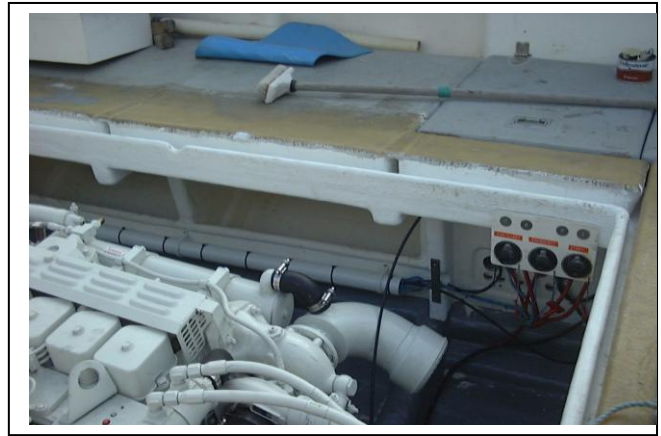
The 3 main battery switches on their panel were refitted next to the battery compartment in the new engine bay. Wiring runs inside the 2-inch plastic pipe. The majority of the electrics needed altering or replacing. Note gear cable next to exhaust bend.

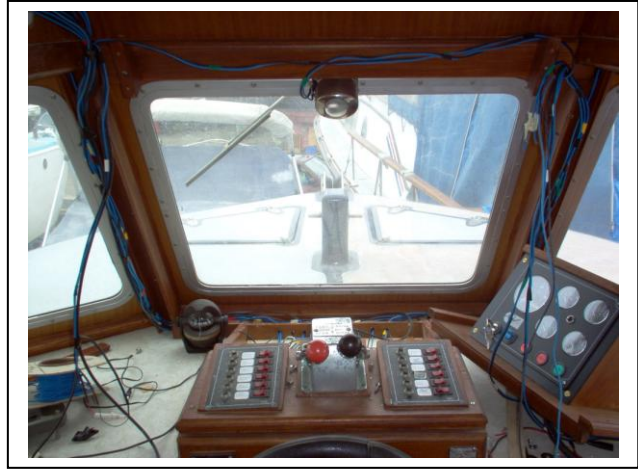
The wiring needed substantial reworking. The new instrument panel was a plug in but the flybridge panel, including alarms, couldn't be piggybacked as before so had to be rewired from source. In addition the new mast meant a rewire of all of the lights and aerials.

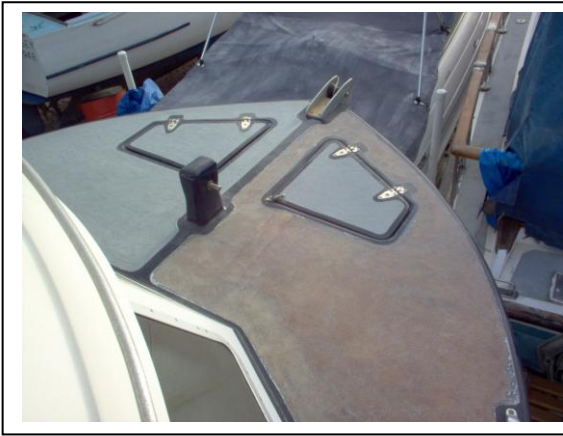
The foredeck gel finish had suffered some wear and tear so rather than trying to patch and match I decided to renew it all. Port side has already been part done with a base coat of grey gel whilst the starboard side is in the ground off state.

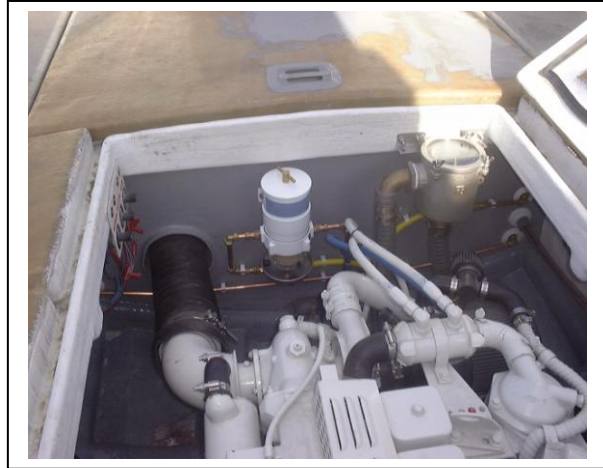
The overview of the rear engine bulkhead shows how neat and accessible everything is.

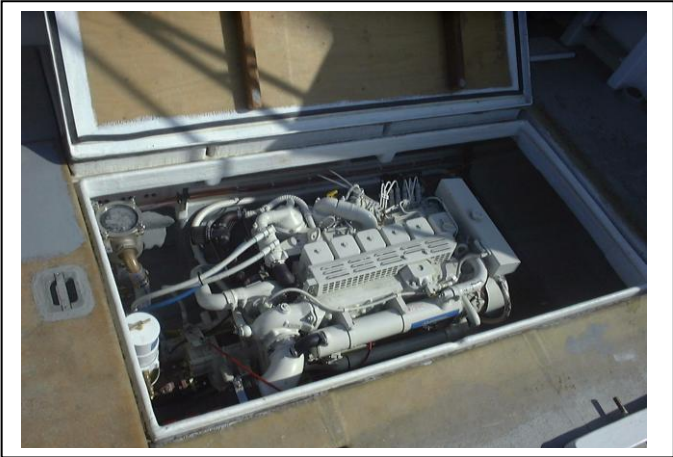
Connected up a fresh water hose and ran the engine. Found a small water leak but otherwise perfect. Fixed the leak and did a second test. Estimate 3 weeks to launch.

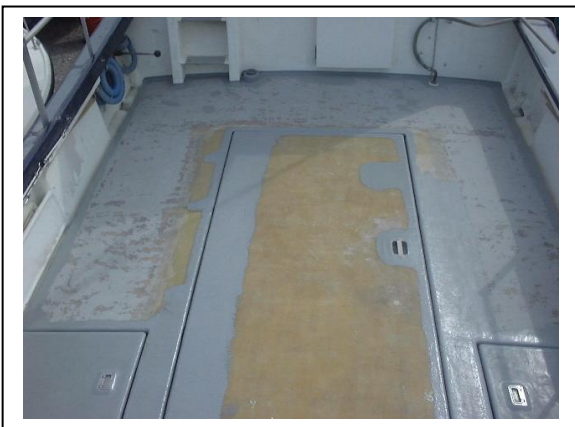
I ground back all of the remaining deck gel, so as to match all of the old with the new. Some of the edges have already been masked and covered with two coats but the rest needs doing. If only it would stop bloody raining.

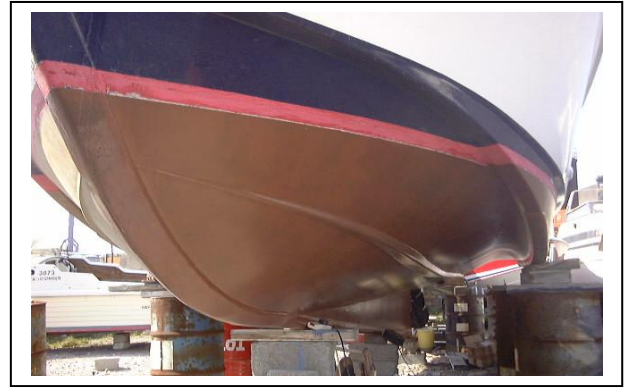
The hull was originally treated with a copper/epoxy mix called Copper Bot. This provided protection and anti foul. After 11 years it was losing its effectiveness so I decided to redo it with the same product now called Copper Coat. Unfortunately I had to sand the old surface to get a key for the new. One weekend plus 3 hours every day after work for a week saw everything sanded using a random orbital sander with 60 grit discs. That was one mother of a job. However, one sunny day saw half the hull coated with 4 coats of the new copper coat. Just the other side to do and hopefully no more anti fouling for another 11 years.
